Solar Weatherization Assistance Program (SWAP)

Reducing Low Income Energy Costs

Florida Solar Energy Center

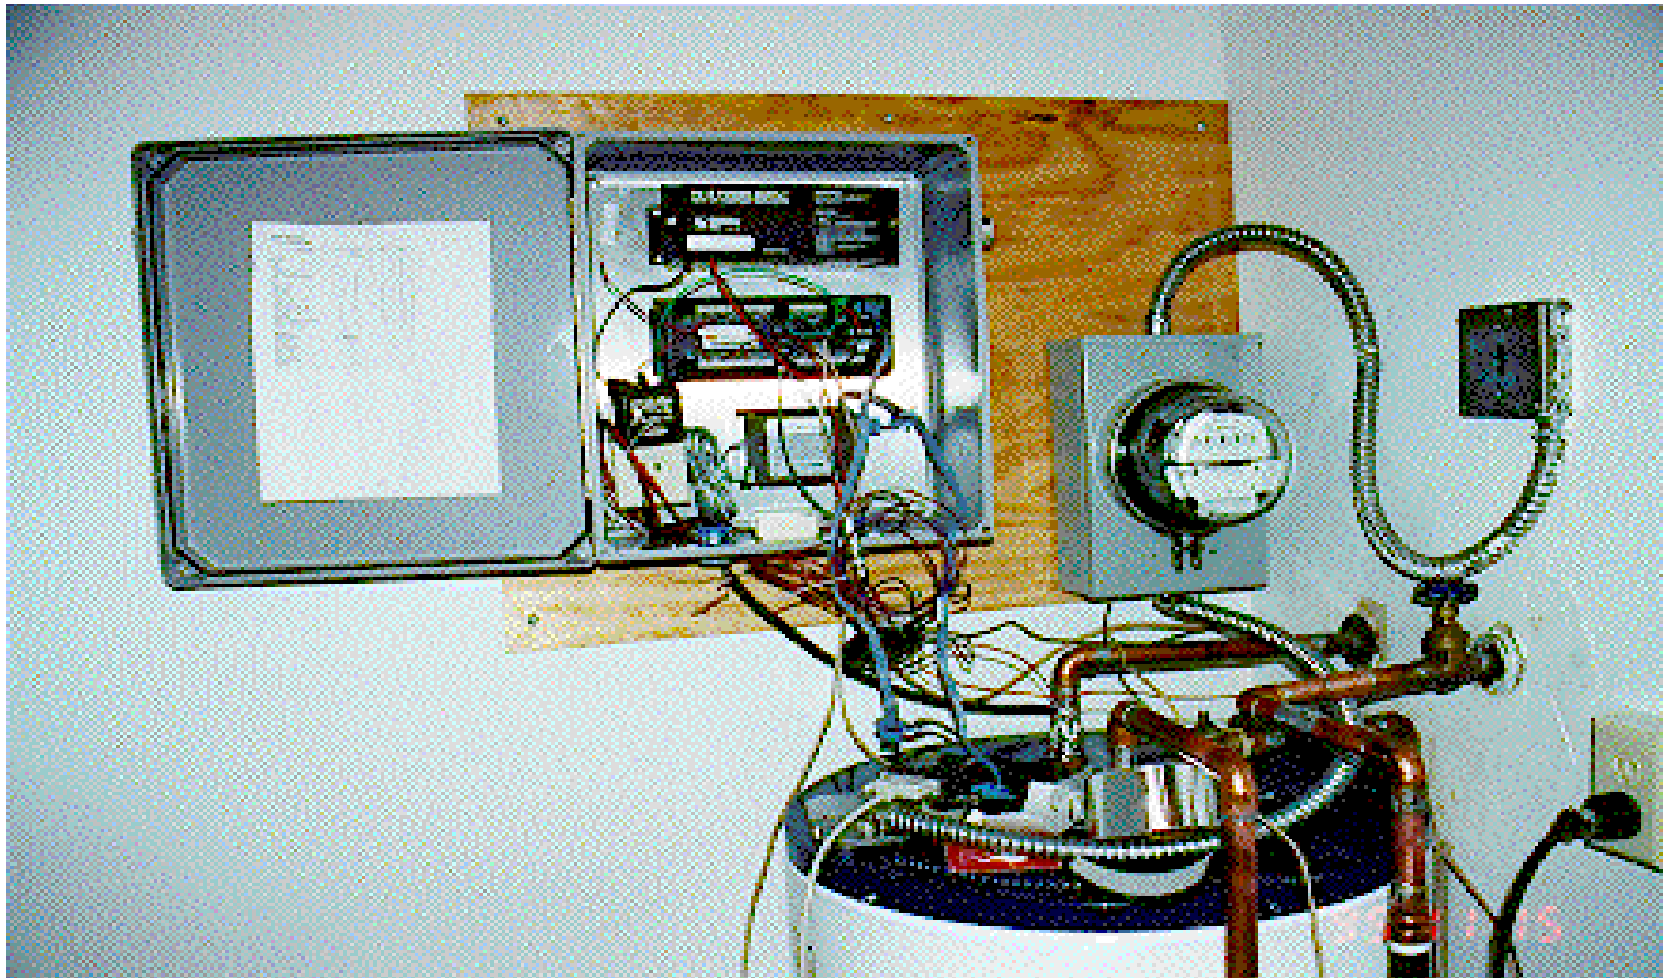
SWAP MONITORING EQUIPMENT

- **Monitored cold water, hot water, collector feed and return temperatures.**
- **Monitored flow to tank and energy usage of tank.**
- **Monitored horizontal solar radiation.**
- **One time measurement of pump and controller power usage.**
- **Scanned data every 15 Sec. Stored averages/totals every 15 Min.**

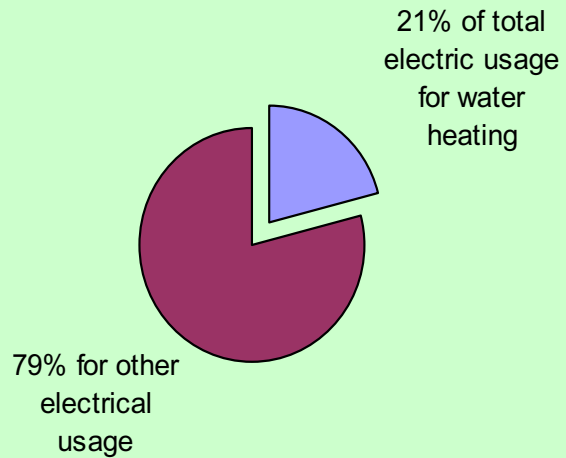
**Percentage of total residence electricity
used to heat water (Pre Solar)**

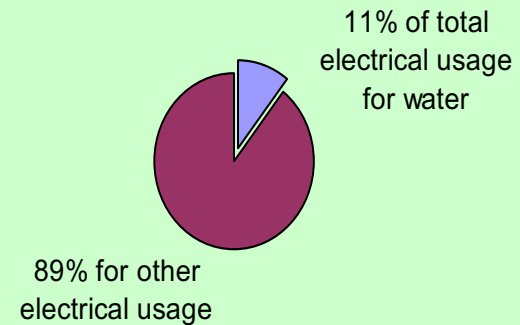
**Percentage of total residence electricity
used to heat water (Post Solar)**

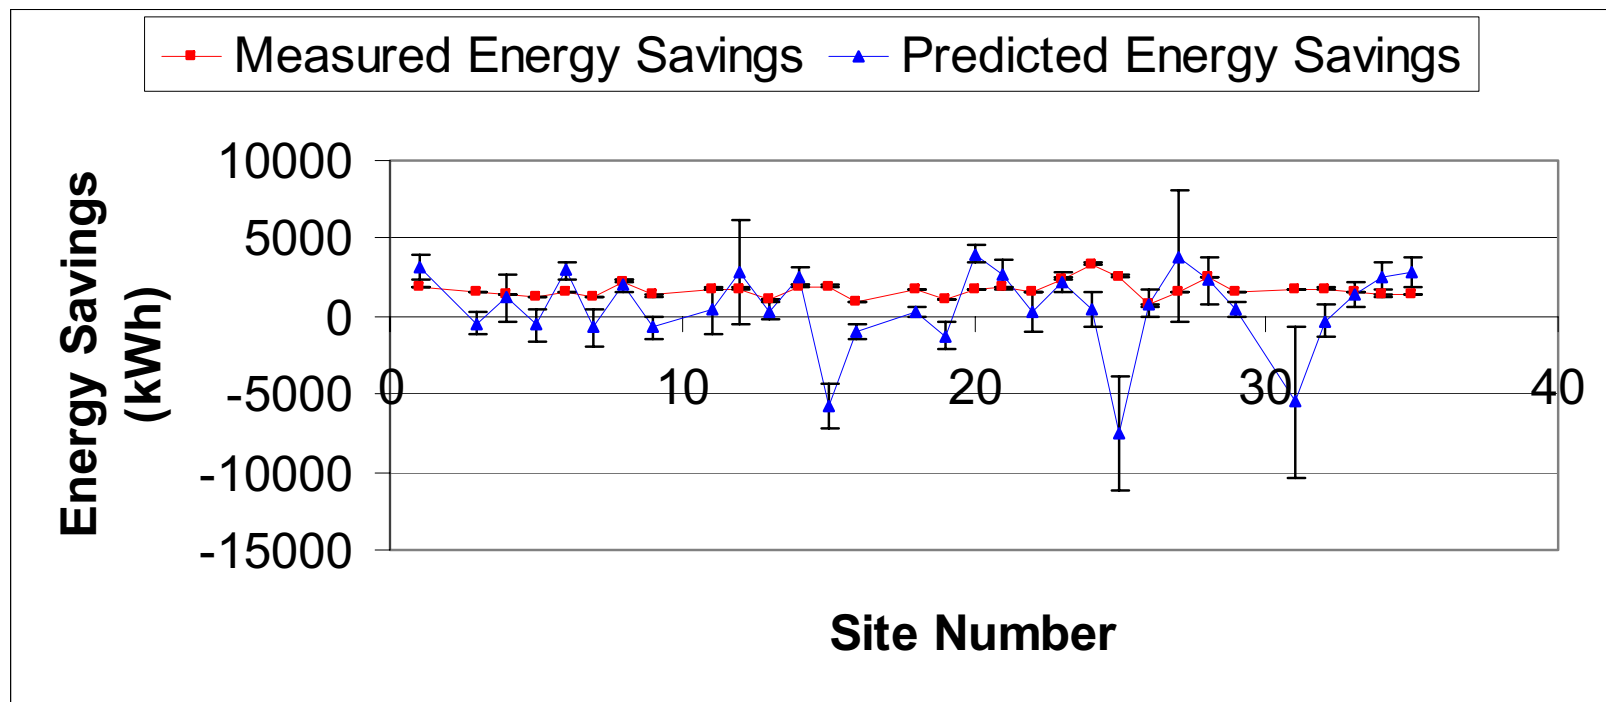
SWAP SOFT MONITORING PRELIMINARY RESULTS

- Evaluate use of utility bill analysis as indicator of energy savings with solar
- Compare with hard monitoring savings
- Preliminary results indicate fair to poor fits with models for predicting annual energy usage
- Overall predicted savings are from 10-82% of measured savings for North, Central, South Florida
